## Toughened glass: A wonderful material, but with an “Achilles heel”

### Introduction – the trouble with nickel sulphide inclusions

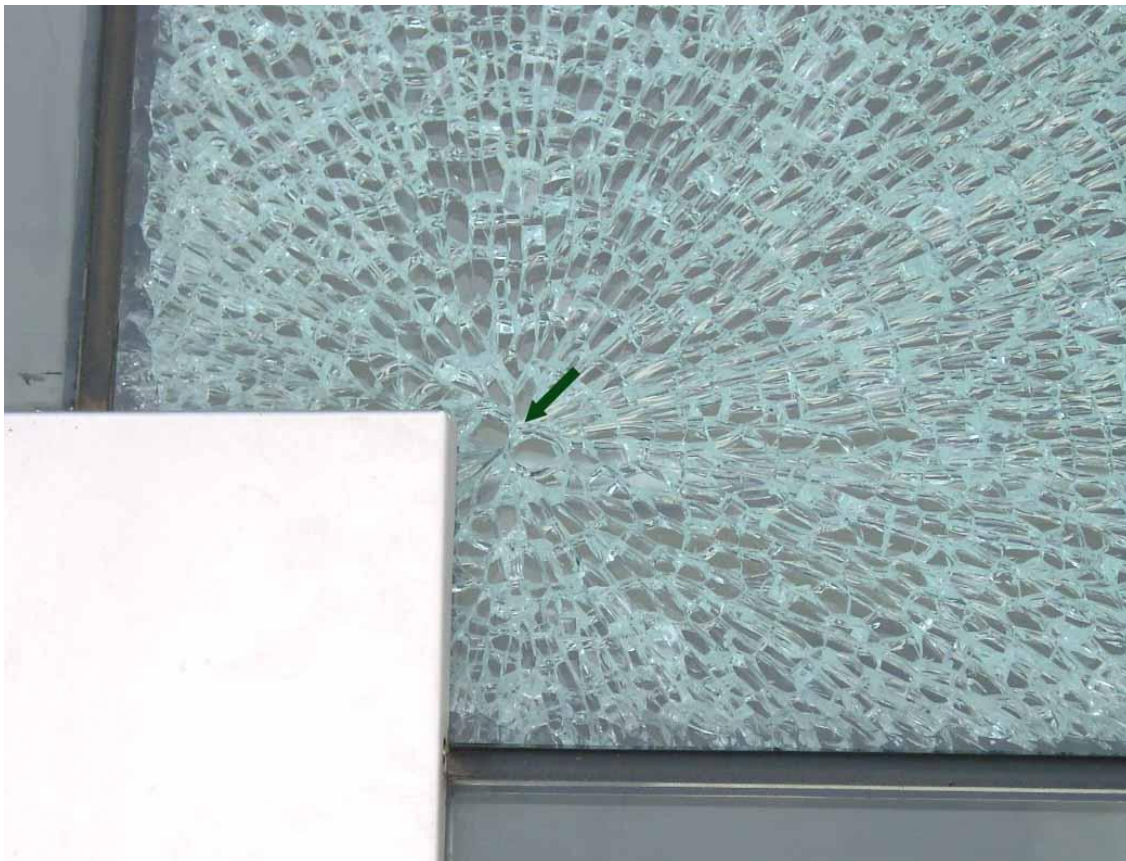
A characteristic “spontaneous” fracture pattern in a toughened glass window. The nickel sulphide inclusion is found at the initiation of failure (at the centre of the butterfly pattern, arrowed)

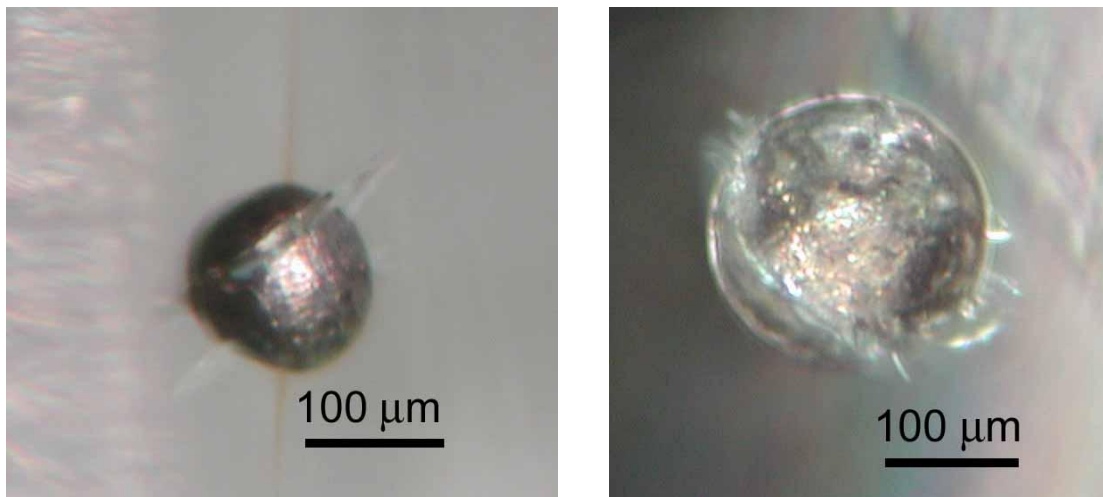
Nickel sulphide inclusions found inside intact glass. There is significant cracking in the glass adjacent to the inclusion, but at the time of photography these cracks were sub-critical.

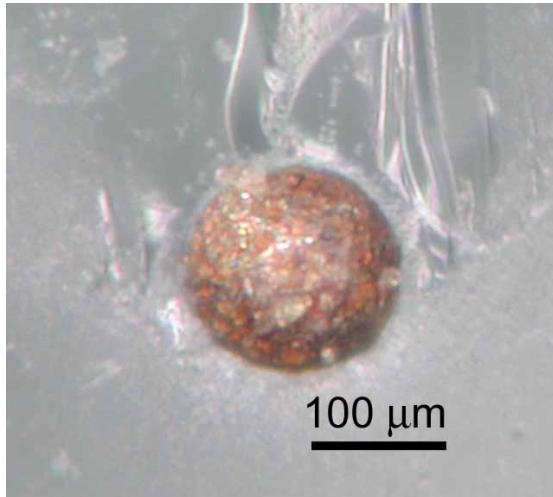
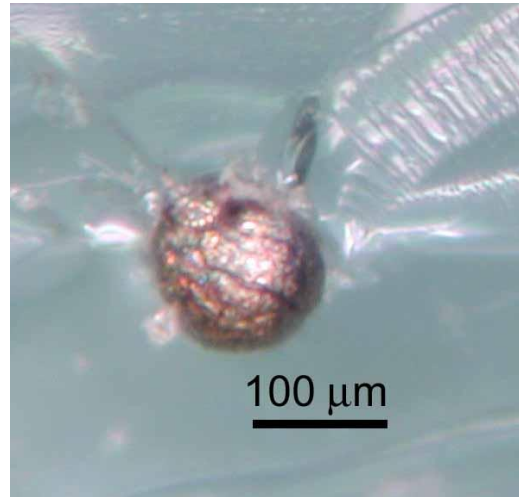
Nickel sulphide inclusions found on fracture surfaces of glass that failed by “spontaneous fracture”.

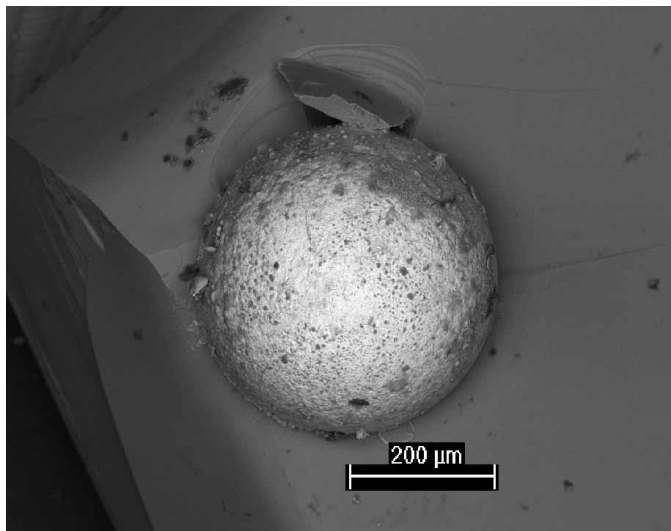
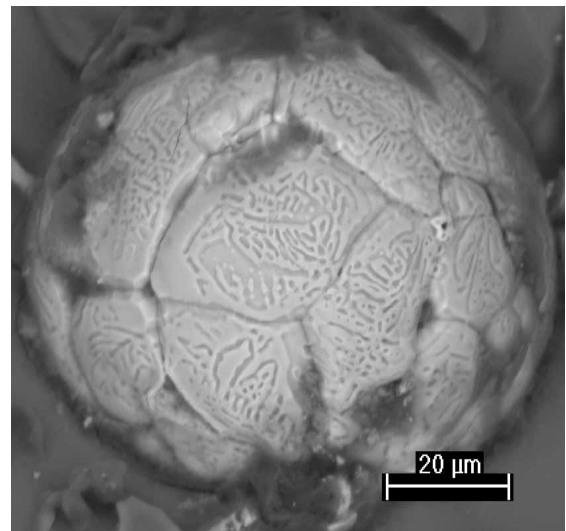
Scanning electron microscopy images of nickel sulphide inclusions found on a fracture surface. The inclusion on the left is quite large (400 μm in diameter), the inclusion on the right is relatively small (85 μm)

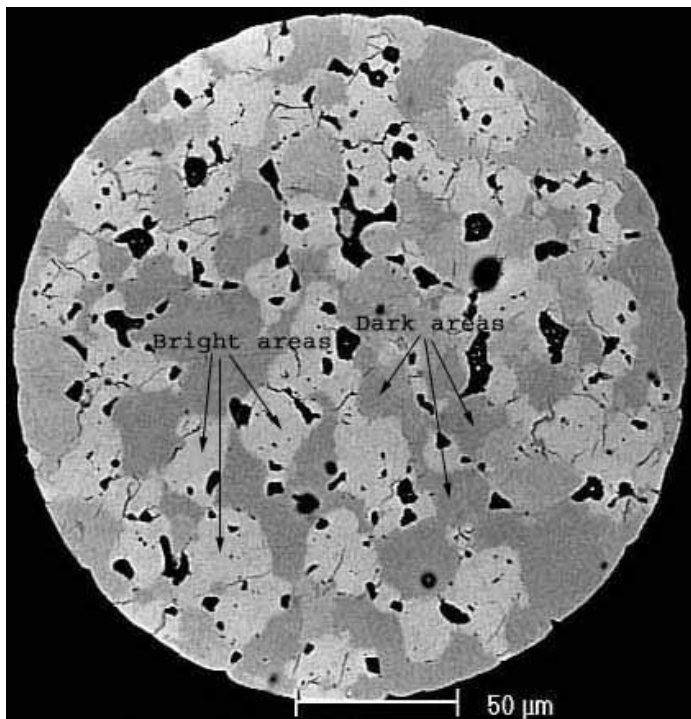
Scanning electron microscopy image of a polished cross-section of a nickel sulphide inclusion. The inclusion is not single phase but rather is a multi-phase assembly of  $\text{Ni}_9\text{S}_8$  and  $\text{Ni}_{1-x}\text{S}$ .

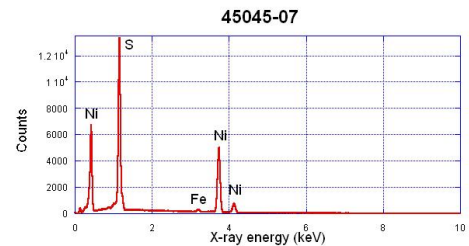
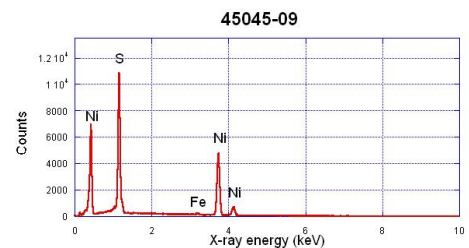
Energy dispersive X-ray spectra generated in a scanning electron microscope. A spectrum from dark areas (above) is sulphur rich as compared with a spectrum from the bright areas (below)
